**Service:** Full Home Inspection

**Prepared for:** Jessica Snyder

Site Address: 437 York Ave, Santa Cruz, CA, 95060

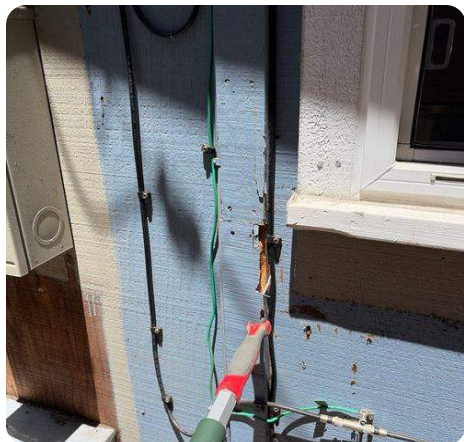
Southside of Home

#### 1 Damaged Trim

Some of the exterior wood trim has moisture or wood damaging insect related damage. Addressing this issue is important as damaged trim affects the aesthetics of the building, and may lead to moisture intrusion and potential structural damage. Contact the appropriate trade to further evaluate and repair or replace the damaged trim. Refer to a current wood damaging organism inspection report for additional information.

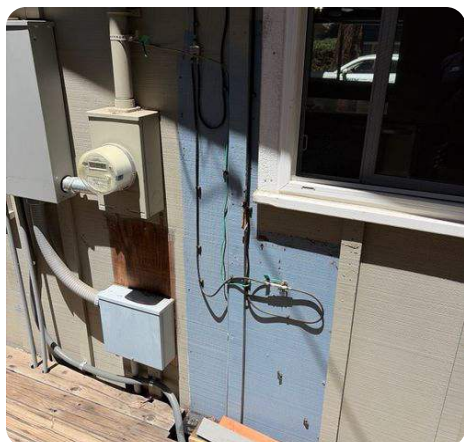
#### 2 Worn Paint

The exterior paint is showing wear in areas. Repainting the worn areas is recommended to provide long term protection and a pleasing look to the exterior structure.

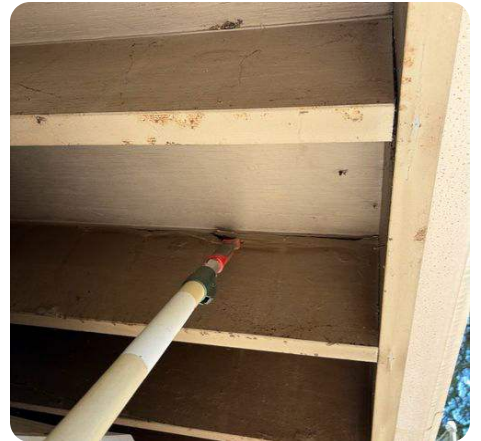
Under balcony

**3 Damaged Wood Members**

There are some damaged wood members in the framing at the deck. We recommend repair or replacement to prevent further deterioration. Contact the appropriate trade for further evaluation and repairs.

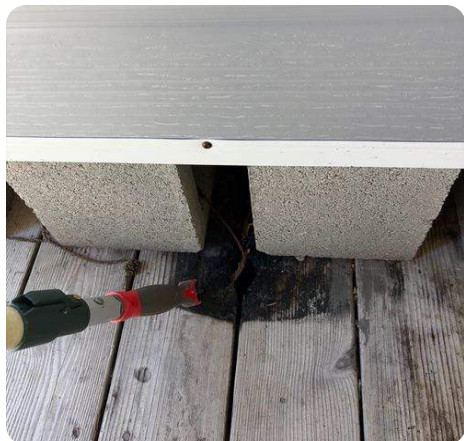
**4 Damaged Surface Boards**

There are some damaged surface boards at the deck. We recommend replacing the damage boards as needed. Contact the appropriate trade for further evaluation and repairs. Refer to the current pest inspection report for additional information.

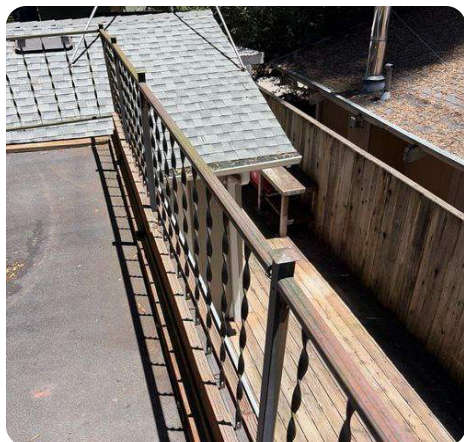
**5 Wobbly Hand Rail Issue**

The handrail on the deck is wobbly, which could pose a safety hazard. It is recommended to evaluate and repair the handrail to ensure stability and safety. A qualified contractor can secure the handrail properly to prevent accidents. Addressing this issue promptly is important to prevent any accidents or injuries.

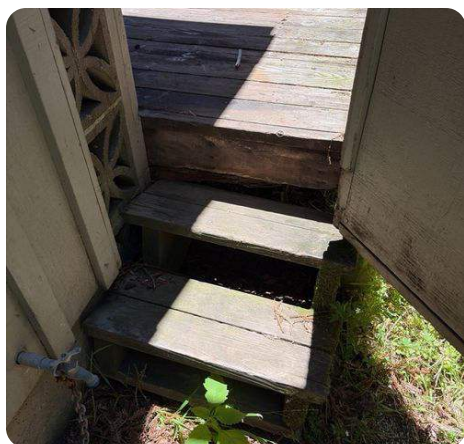
**6 Damaged Steps**

Damage to the steps was observed, which could present a safety hazard. It is important to have a qualified contractor evaluate and repair the damaged steps promptly to prevent accidents or further deterioration.

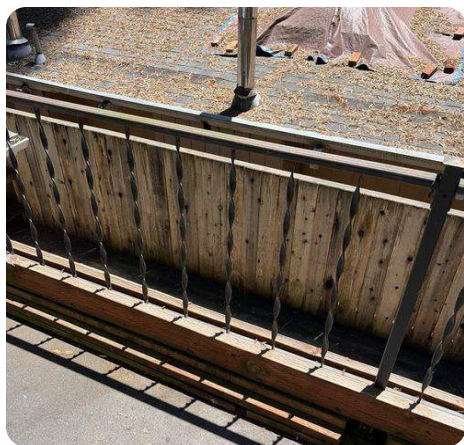
#### 7 Baluster Spacing Issue

The baluster spacing on the porch does not meet the recommended guidelines. Balusters are the vertical support posts forming the guardrail or handrail system on the stairs. The spacing should not exceed 4 inches to prevent incidents of small children getting stuck or falling through. It is recommended to assess and fix the baluster spacing to enhance the safety of the rails. A qualified contractor or repair person should be contacted for this repair.

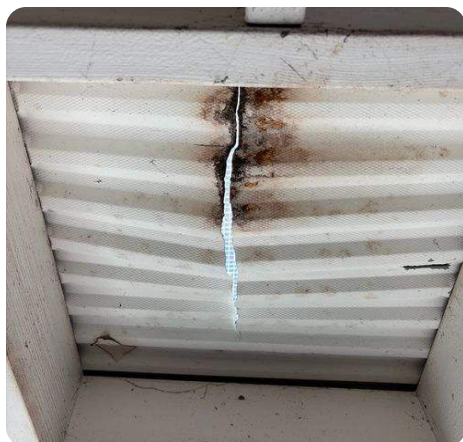
## 9 Damaged Patio Cover

Damage was observed to the roof covering material of the patio cover at the time of the inspection. Damaged roof covering materials may allow moisture intrusion and can lead to further deterioration if not addressed. Contact or qualified trades person for further evaluation or repair

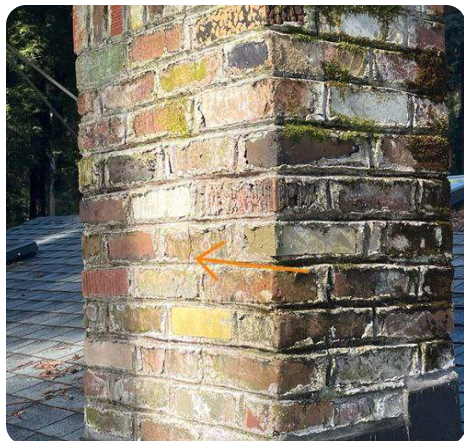
## 10 Cracks In Chimney

There are cracks at the chimney area. These cracks should be repaired to prevent moisture intrusion and deterioration. It is recommended that appropriate repairs be carried out by a qualified chimney inspection company.

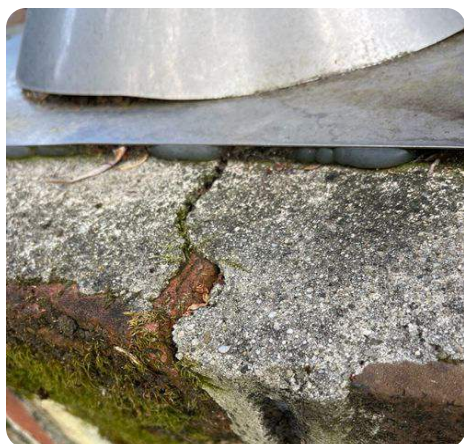
**11 Cracked Mortar Cap On Chimney**

The chimney has a cracked mortar cap. This issue is located at the top of the chimney. It is recommended to evaluate and repair the cracked mortar cap to prevent water infiltration which can lead to further damage. A qualified mason can repair the cracked mortar cap to ensure the chimney remains in good condition. Regular maintenance and sealing of the chimney can help prevent future cracks in the mortar cap.

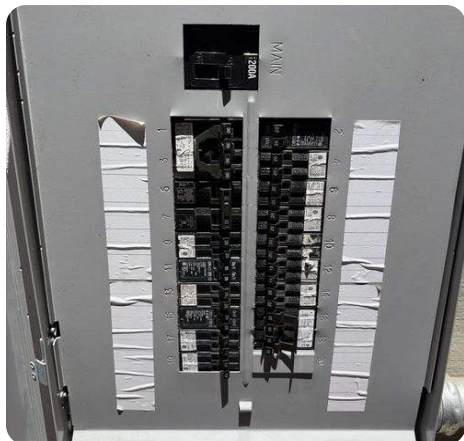
The breakers do not have the benefit of proper and/or complete service labeling. The inspector recommends labeling the breakers in order to provide quick identification of service disconnects in the event of an emergency.

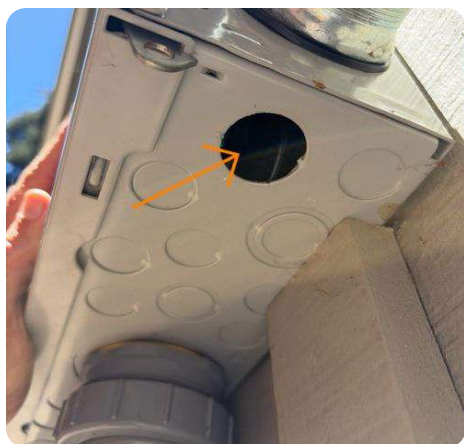
### 13 Open Knockout

There is one or more open knockout holes on an electric panel. All openings should be plugged with an approved knockout cover in order to keep pests out of the panel. Repair by a qualified electrical contractor is recommended.

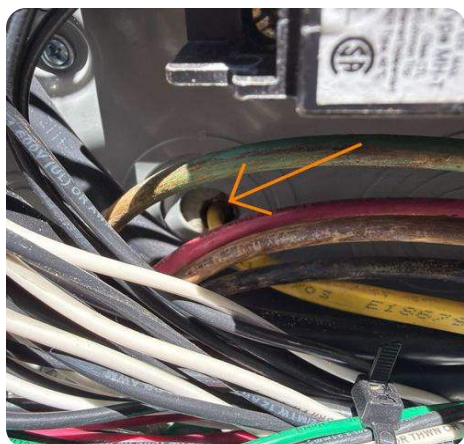
### 14 Missing Strain Relief.

There is no strain relief for some of the wiring routed through the top and bottom of the listed electrical panel. The inspector recommends that strain relief grommets be installed as a preventive measure against any potential damage or abrasion of the wire insulation/sheathing over time. A licensed electrician should perform this task for safety reasons.

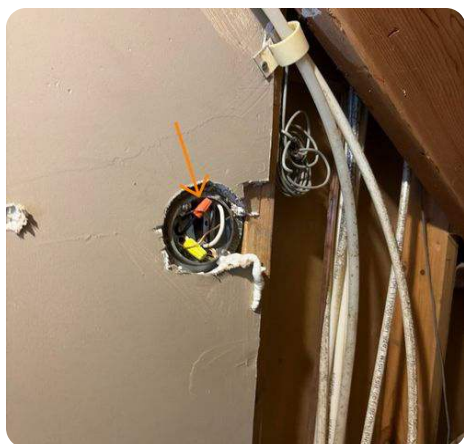
**15 Exposed Wiring**

Exposed wiring was observed at the property. This poses a safety issue that should be addressed promptly to mitigate the risk of electrical shock and other potential hazards. It is recommended to contact a qualified electrician to evaluate and repair the exposed wiring.

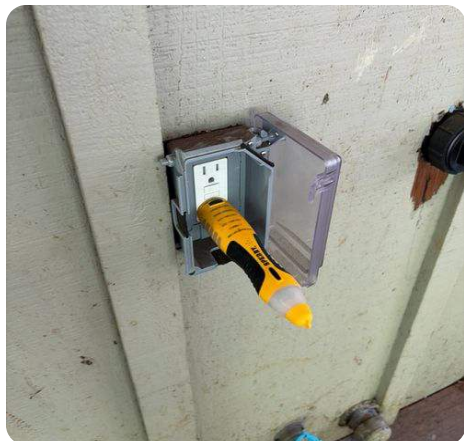
Front of home

One outlet in the home does not have electrical power. The inspector found no tripped breakers or tripped GFCI's. We recommend contacting a reputable licensed electrician for further assessment and correction of this issue.

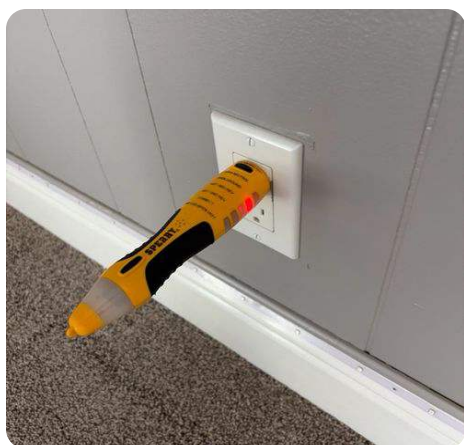
Upstairs south bedroom

One or more outlets were found to have an open ground. Correcting the open grounds in the electrical system is recommended to ensure safety for occupants and proper functioning of the outlets. A qualified electrician should be hired to evaluate and repair this issue.

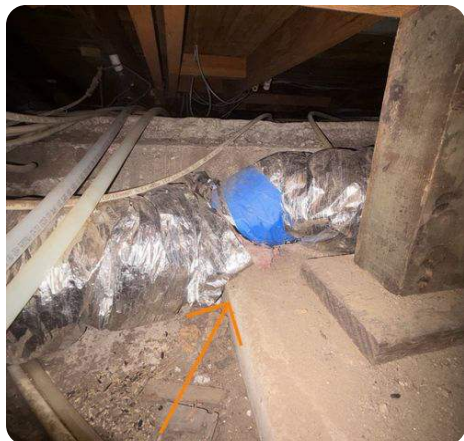
The HVAC ducting within the crawlspace was found to be in direct contact with the soil. Soil contact leads to ducting deterioration over time and it is recommended that the installation be further evaluated and either repaired or replaced by a heating and air conditioning professional.

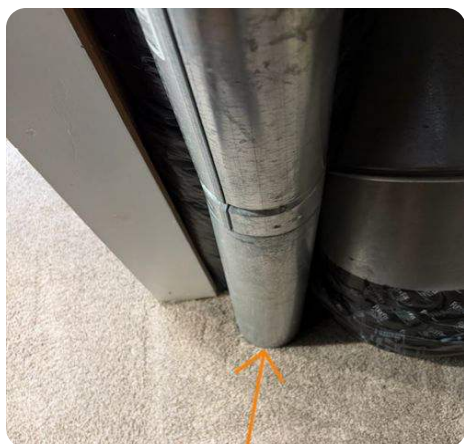
**23 Furnace Flu In Contact With Carpet**

The furnace flue was observed in contact with carpet. Flue venting components should be installed with the required clearance from combustibile materials in accordance with the manufacturer's installation instructions and applicable building standards. Improper clearance may present a potential fire hazard. Contact to qualified HVAC technician for further evaluation or repair.

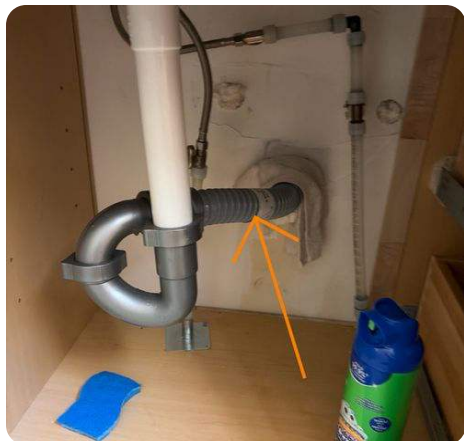
Downstairs bathroom

Flex piping was observed in the drain, waste, and vent system. While flexible and easy to install, it is important to be aware that flex piping may be more susceptible to leaks and may not be appropriate for all uses. It is recommended to assess the condition of the flex piping and consider necessary repairs or upgrades. Contact a qualified plumber to evaluate the suitability of the flex piping and determine if any repairs or replacements are needed.

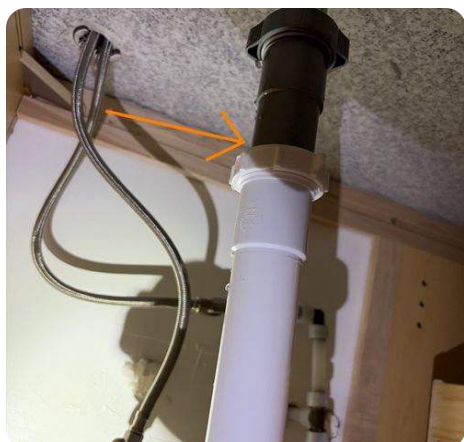
Downstairs bathroom

**25 Waste Line Drain Leak**

A leak was observed in the drain/waste, line. Evaluating the plumbing system's integrity and addressing any leaks is crucial to avoid additional damage and potential water-related issues. Contact a qualified plumber for further evaluation and repairs.

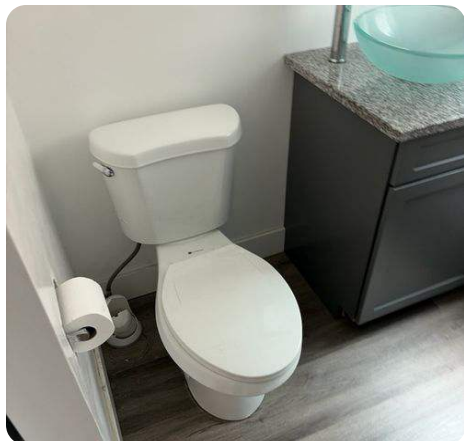
Downstairs bathroom

**26 Loose Toilet**

One or more toilets were found to be loose, as evident by movement or rocking when pressure is applied. A loose toilet may cause leaking or damage to the wax seal, potentially resulting in water damage to the subfloor or ceiling below. It is recommended to assess and repair the toilet promptly to avoid future issues. Contact a qualified plumber to correctly secure the toilet.

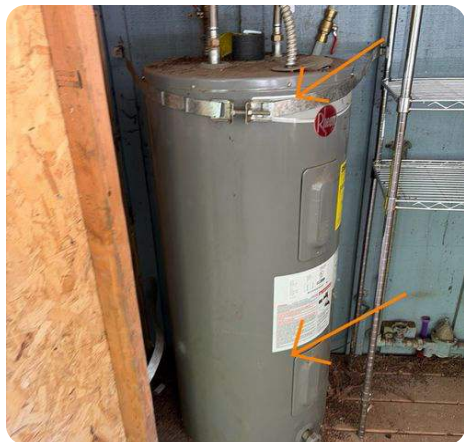
The water heater is equipped with one seismic strap. This current standards are that there be two tie down straps around the top and bottom 1/3s of the tank to prevent it from moving in the event of an earthquake. In addition, the fasteners securing the present strap are undersized and do not meet current standards. Contact a qualified handyman for installation of an appropriate size strapping system.

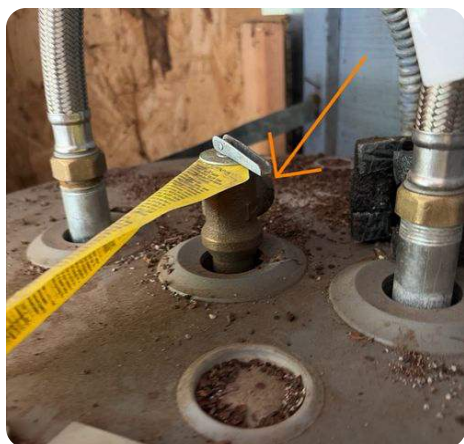
### 28 Missing Discharge Pipe

There is no discharge pipe attached to the water heater's temperature pressure relief valve. This pipe is essential to prevent someone from being sprayed with hot water if the valve is activated. While activation of the temperature/pressure relief valve is uncommon, it typically indicates that the water heater requires servicing or adjustments. For safety, it is recommended to install an approved discharge pipe that terminates 6-24 inches from the floor or to the exterior.

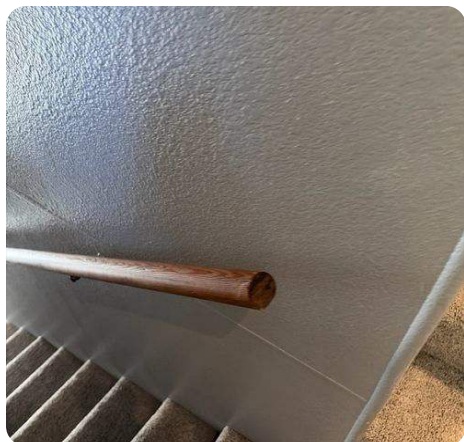
### 30 Handrail Returns Recommended

The handrail at the interior stairway is missing returns to the wall at the ends of the rail. A return is meant to help prevent falls and injury. We recommend contacting a qualified contractor for repairs.

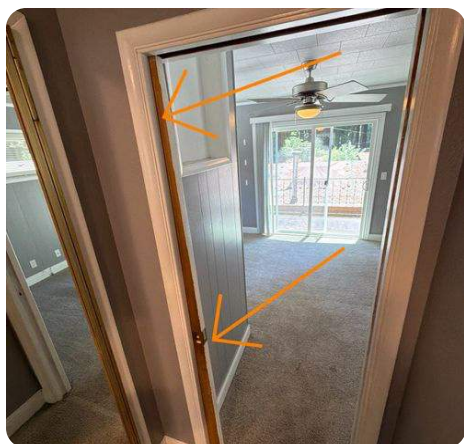
### 31 Pocket Door Off Track

The pocket door is off track. This issue can lead to difficulty in opening or closing the door properly. It is recommended to evaluate and repair the pocket door track to ensure smooth functionality. A qualified carpenter or handyman can assist in realigning the door on track.

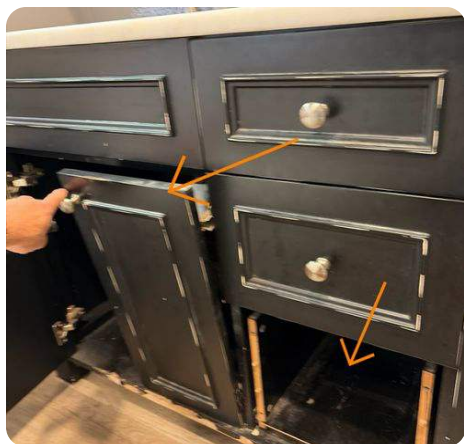
Upstairs bathroom

### 34 Damaged Cabinet

The cabinet has damage that can affect its appearance and functionality. It is recommended to have the damaged area evaluated and repaired by a qualified cabinet repair professional to restore it to its original condition.

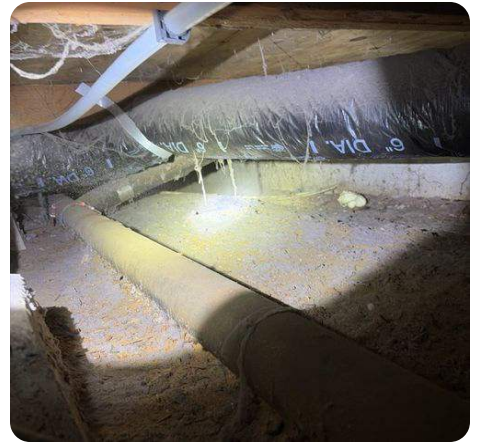
The dryer vent is disconnected. This issue can lead to moisture build-up and potential mold growth. It is recommended to evaluate and repair the dryer vent by reattaching it securely to ensure proper ventilation. A qualified HVAC technician can assist in reconnecting the dryer vent to prevent any further issues.

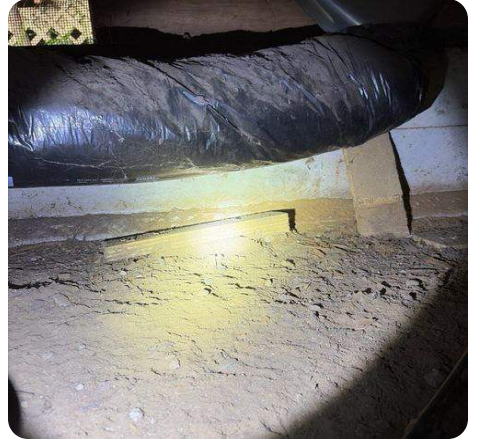
Scrap wood and other debris was noted in the crawl space. Recommend removal of all scrap wood and debris from the crawl space as wood debris/cellulose can lead to insect infestation.

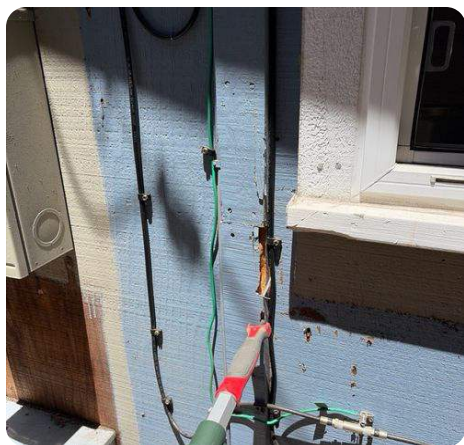
Southside of Home

#### Damaged Trim

Some of the exterior wood trim has moisture or wood damaging insect related damage. Addressing this issue is important as damaged trim affects the aesthetics of the building, and may lead to moisture intrusion and potential structural damage. Contact the appropriate trade to further evaluate and repair or replace the damaged trim. Refer to a current wood damaging organism inspection report for additional information.

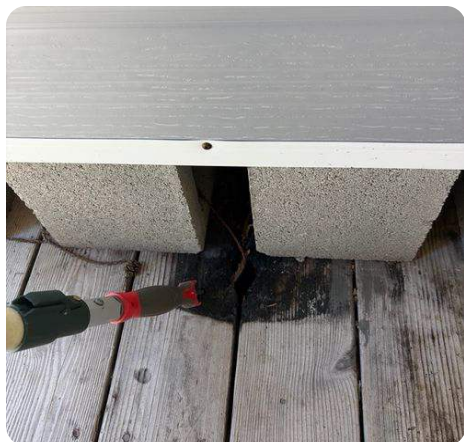
## Damaged Surface Boards

There are some damaged surface boards at the deck. We recommend replacing the damage boards as needed. Contact the appropriate trade for further evaluation and repairs. Refer to the current pest inspection report for additional information.

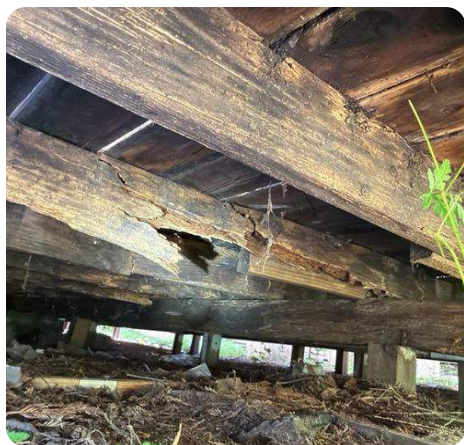
Back deck

## Damaged Wood Members

There are some damaged wood members in the framing at the deck. We recommend repair or replacement to prevent further deterioration. Contact the appropriate trade for further evaluation and repairs.

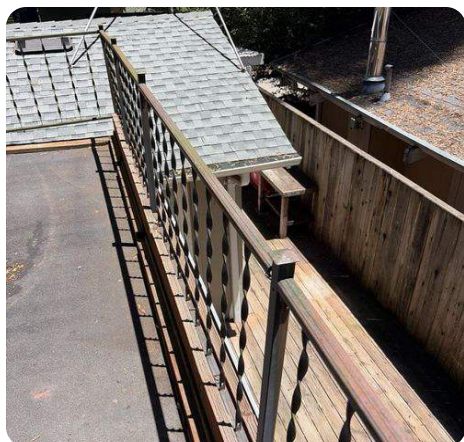
The handrail on the deck is wobbly, which could pose a safety hazard. It is recommended to evaluate and repair the handrail to ensure stability and safety. A qualified contractor can secure the handrail properly to prevent accidents. Addressing this issue promptly is important to prevent any accidents or injuries.

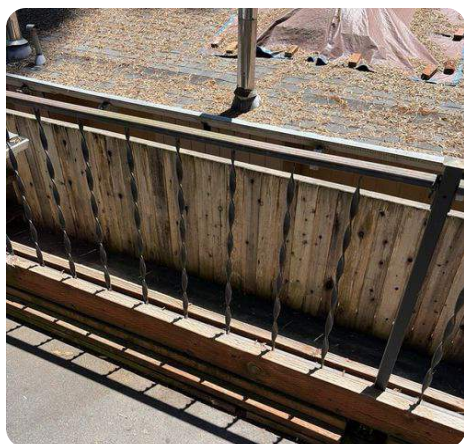
#### Baluster Spacing Issue

The baluster spacing on the porch does not meet the recommended guidelines. Balusters are the vertical support posts forming the guardrail or handrail system on the stairs. The spacing should not exceed 4 inches to prevent incidents of small children getting stuck or falling through. It is recommended to assess and fix the baluster spacing to enhance the safety of the rails. A qualified contractor or repair person should be contacted for this repair.

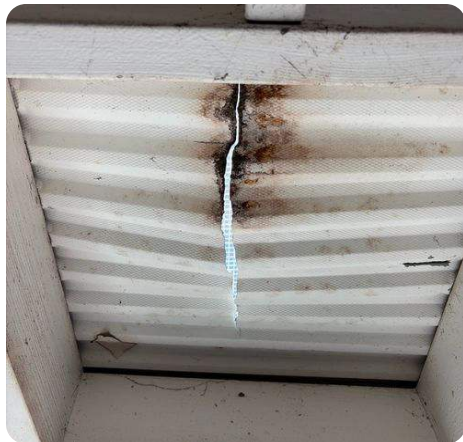
Damage was observed to the roof covering material of the patio cover at the time of the inspection. Damaged roof covering materials may allow moisture intrusion and can lead to further deterioration if not addressed. Contact or qualified trades person for further evaluation or repair

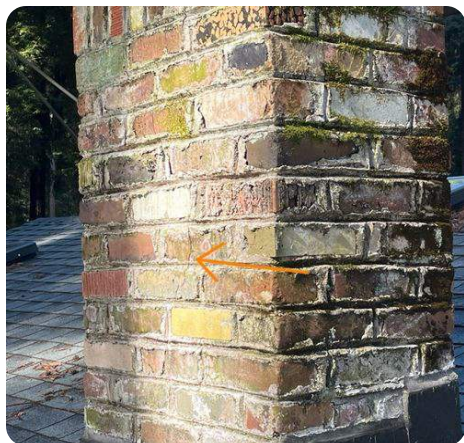
There are cracks at the chimney area. These cracks should be repaired to prevent moisture intrusion and deterioration. It is recommended that appropriate repairs be carried out by a qualified chimney inspection company.

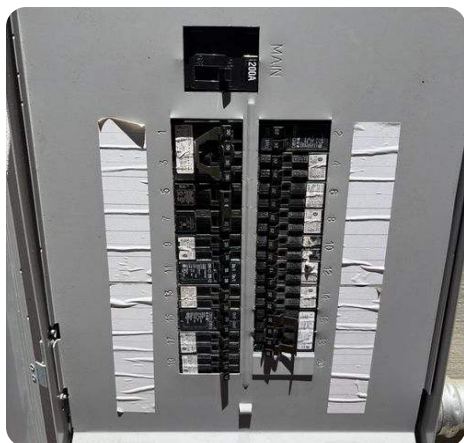
The breakers do not have the benefit of proper and/or complete service labeling. The inspector recommends labeling the breakers in order to provide quick identification of service disconnects in the event of an emergency.

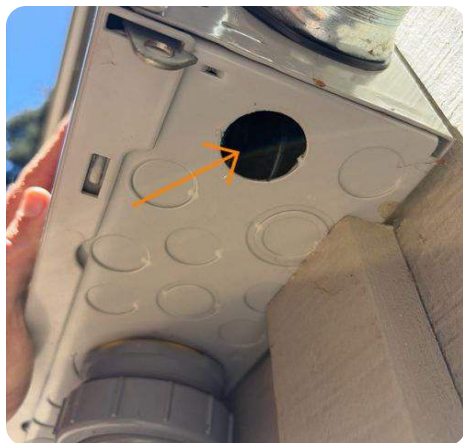
There is one or more open knockout holes on an electric panel. All openings should be plugged with an approved knockout cover in order to keep pests out of the panel. Repair by a qualified electrical contractor is recommended.

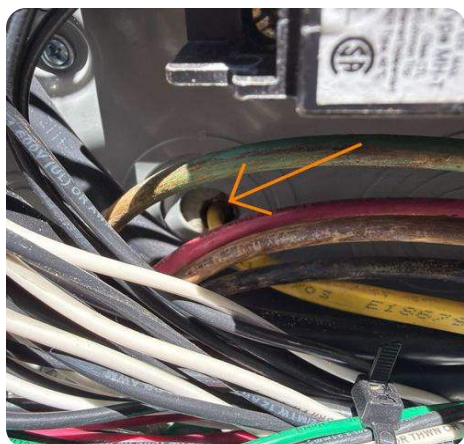
##### Missing Strain Relief.

There is no strain relief for some of the wiring routed through the top and bottom of the listed electrical panel. The inspector recommends that strain relief grommets be installed as a preventive measure against any potential damage or abrasion of the wire insulation/sheathing over time. A licensed electrician should perform this task for safety reasons.
