**Service:** Full Home Inspection

**Prepared for:** Jessica Snyder

Site Address: 437 York Ave, Santa Cruz, CA, 95060

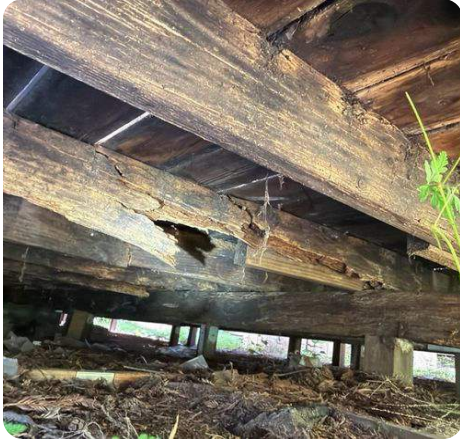
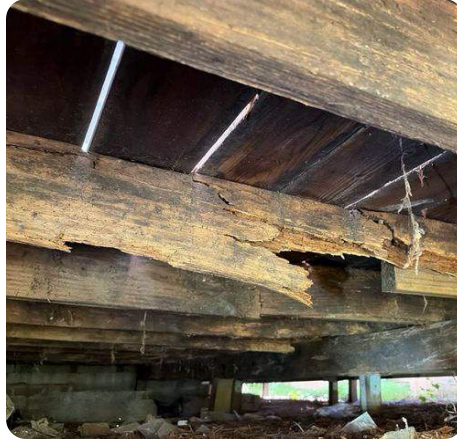
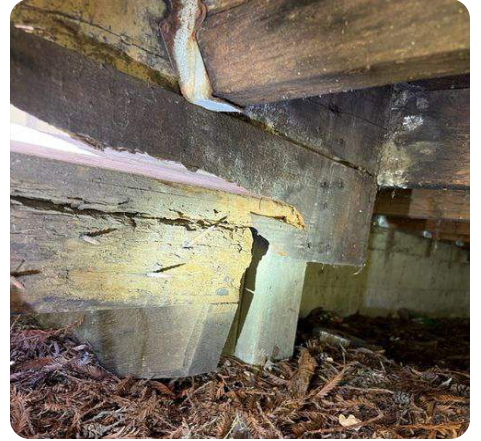
Back deck

**3 Damaged Wood Members**

There are some damaged wood members in the framing at the deck. We recommend repair or replacement to prevent further deterioration. Contact the appropriate trade for further evaluation and repairs.

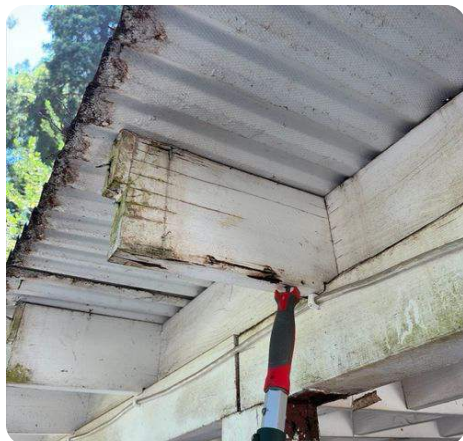
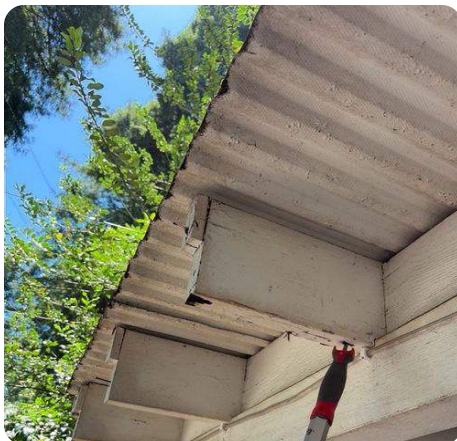
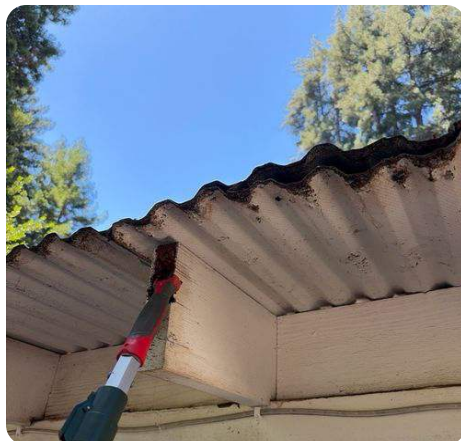
#### 8 Overhead Framing Damage At Cover

There is damage to the structural members at the South porch cover. Further examination is needed to determine the extent of the damage. We recommend you contact a qualified trade or refer to a current pest and dry rot report for recommended repairs.

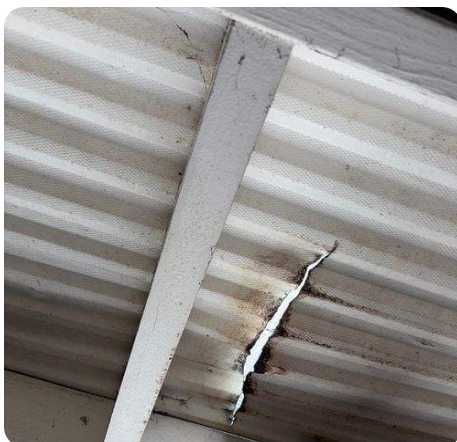
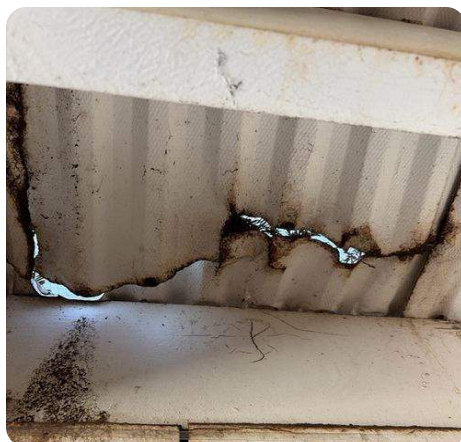
## 9 Damaged Patio Cover

Damage was observed to the roof covering material of the patio cover at the time of the inspection. Damaged roof covering materials may allow moisture intrusion and can lead to further deterioration if not addressed. Contact or qualified trades person for further evaluation or repair

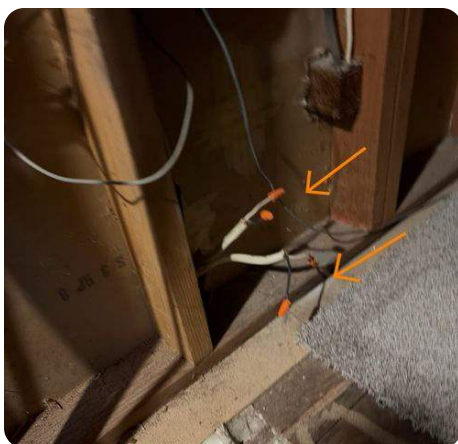
Exposed wiring was observed at the property. This poses a safety issue that should be addressed promptly to mitigate the risk of electrical shock and other potential hazards. It is recommended to contact a qualified electrician to evaluate and repair the exposed wiring.

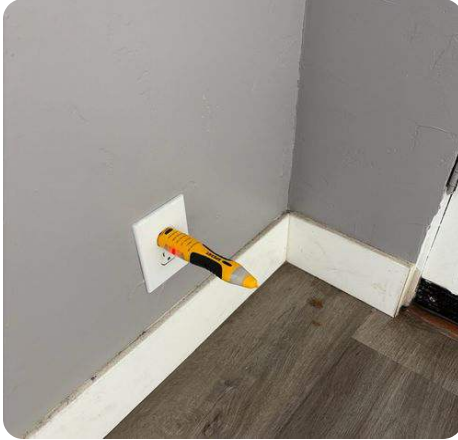
Near front door

**16 Reversed Hot Neutral Wiring**

The interior GFCI outlet has reverse hot neutral wiring, which can pose a safety hazard. This issue should be evaluated and repaired by a qualified electrician to ensure proper wiring and prevent potential electrical shocks or damage to appliances connected to the outlet.

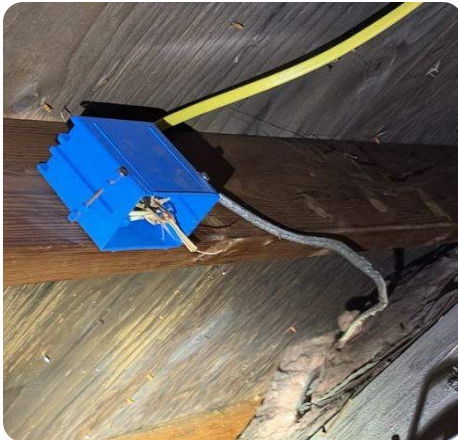
Attic

#### 17 Open Junction Box

An open junction box containing exposed wire connections was observed within the home at the time of the inspection. Junction box covers offer protection to the wire connections, limits debris and rodent access, while containing any potential arcing within the box. It is recommended that an approved cover be installed by a qualified professional.

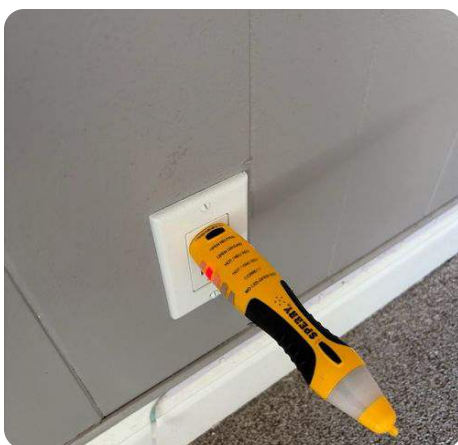
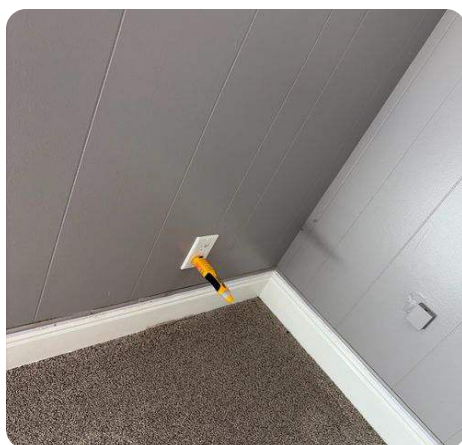
Upstairs south bedroom

One or more outlets were found to have an open ground. Correcting the open grounds in the electrical system is recommended to ensure safety for occupants and proper functioning of the outlets. A qualified electrician should be hired to evaluate and repair this issue.

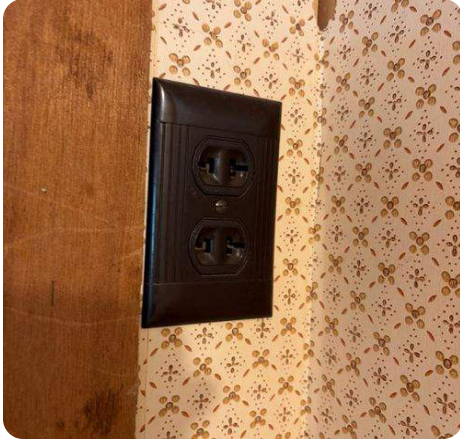
Upstairs bedroom closet

**20** Two Prong Outlets Present

The presence of one or more two-prong outlets was observed. It is recommended to upgrade these outlets to three-prong outlets to ensure proper grounding and to meet modern electrical safety standards. This upgrade should be performed by a licensed electrician to ensure compliance with local building codes.

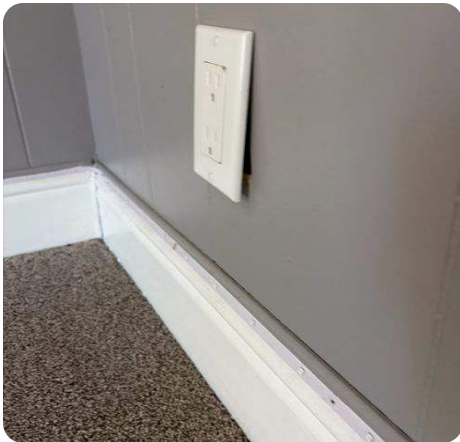
Upstairs south bedroom

**21 Loose Outlet**

There is a loose outlet in the home which could lead to connectivity issues and pose a safety hazard. It is recommended to evaluate and repair the outlet as soon as possible. A qualified electrician should be contacted to properly address and fix the loose outlet to ensure safety and functionality.

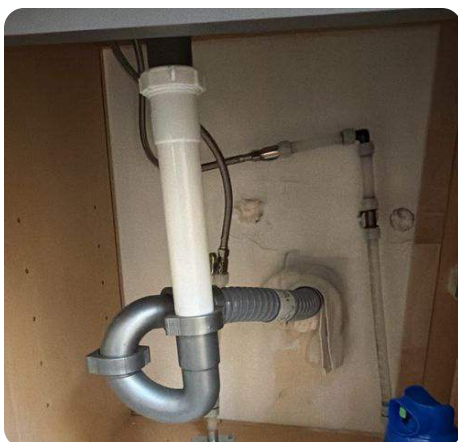
Downstairs bathroom

**25 Waste Line Drain Leak**

A leak was observed in the drain/waste, line. Evaluating the plumbing system's integrity and addressing any leaks is crucial to avoid additional damage and potential water-related issues. Contact a qualified plumber for further evaluation and repairs.

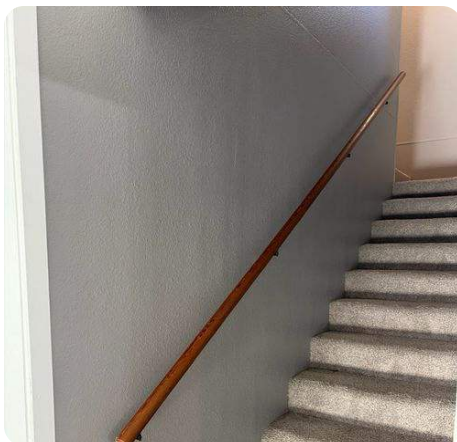
### 30 Handrail Returns Recommended

The handrail at the interior stairway is missing returns to the wall at the ends of the rail. A return is meant to help prevent falls and injury. We recommend contacting a qualified contractor for repairs.

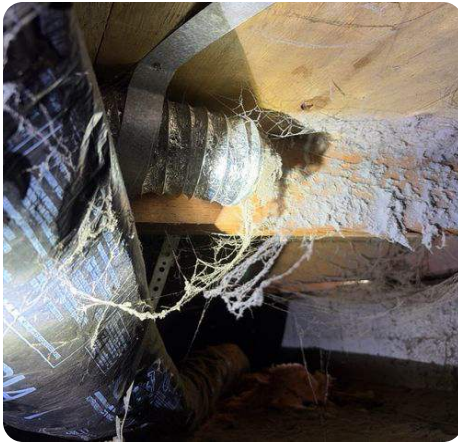
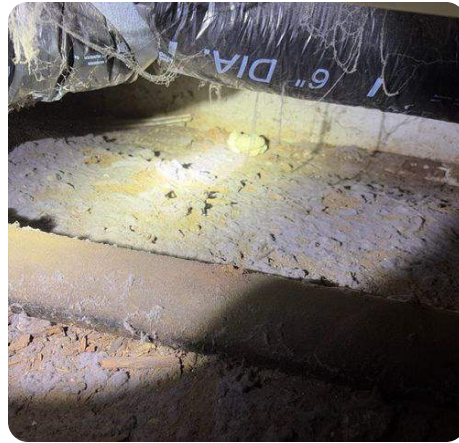
The dryer vent is disconnected. This issue can lead to moisture build-up and potential mold growth. It is recommended to evaluate and repair the dryer vent by reattaching it securely to ensure proper ventilation. A qualified HVAC technician can assist in reconnecting the dryer vent to prevent any further issues.

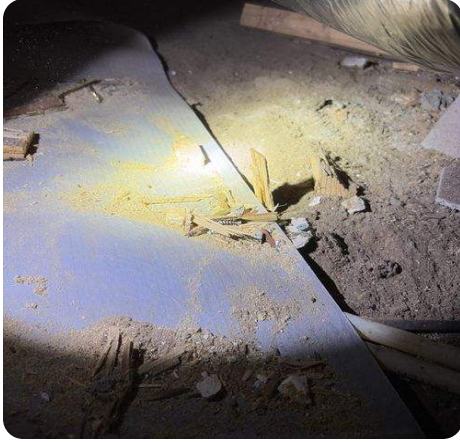
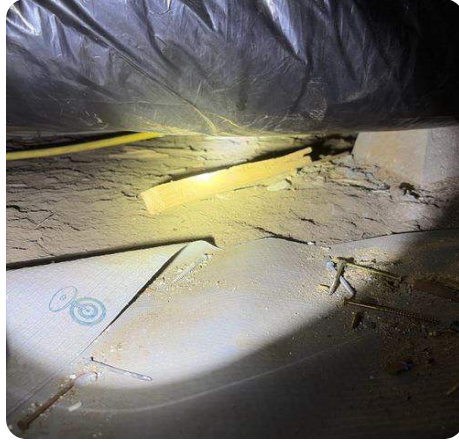
### 37 Debris In Crawl Space

Scrap wood and other debris was noted in the crawl space. Recommend removal of all scrap wood and debris from the crawl space as wood debris/cellulose can lead to insect infestation.

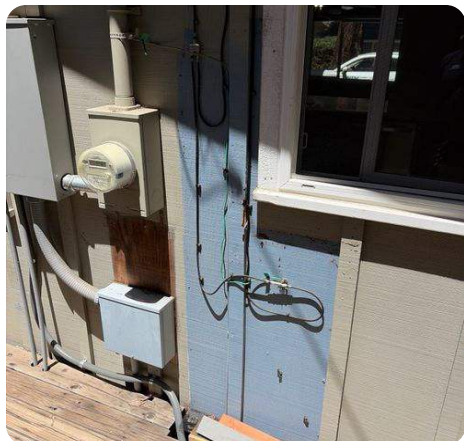
### Worn Paint

The exterior paint is showing wear in areas. Repainting the worn areas is recommended to provide long term protection and a pleasing look to the exterior structure.

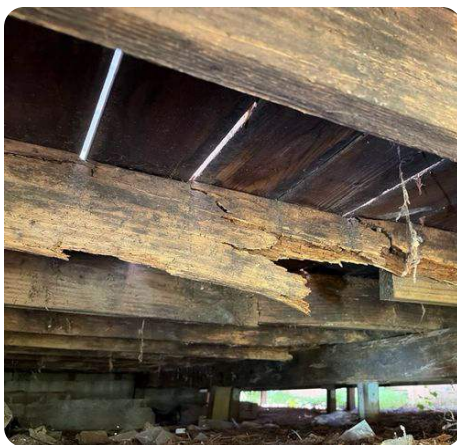
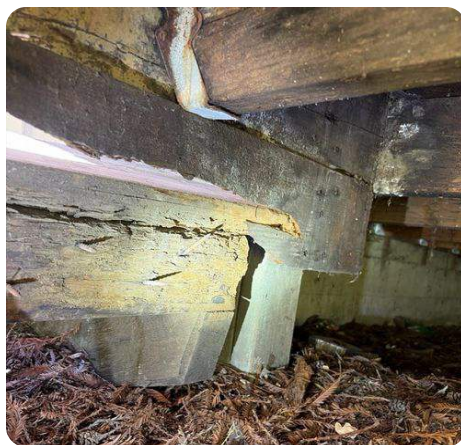
Back deck

## Damaged Surface Boards

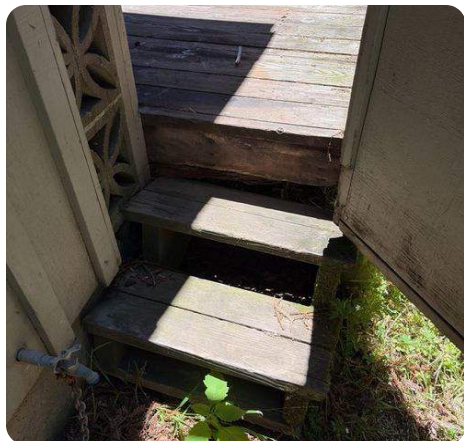
### Damaged Steps

Damage to the steps was observed, which could present a safety hazard. It is important to have a qualified contractor evaluate and repair the damaged steps promptly to prevent accidents or further deterioration.

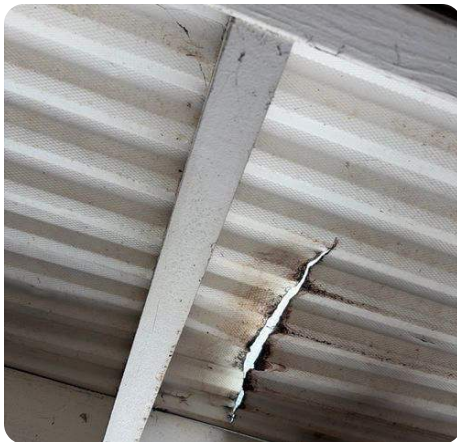
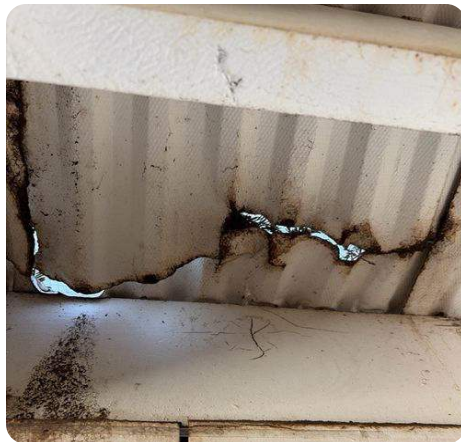
Damage was observed to the roof covering material of the patio cover at the time of the inspection. Damaged roof covering materials may allow moisture intrusion and can lead to further deterioration if not addressed. Contact or qualified trades person for further evaluation or repair

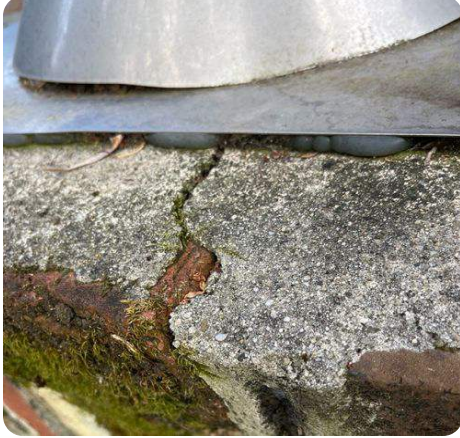
### Cracked Mortar Cap On Chimney

The chimney has a cracked mortar cap. This issue is located at the top of the chimney. It is recommended to evaluate and repair the cracked mortar cap to prevent water infiltration which can lead to further damage. A qualified mason can repair the cracked mortar cap to ensure the chimney remains in good condition. Regular maintenance and sealing of the chimney can help prevent future cracks in the mortar cap.

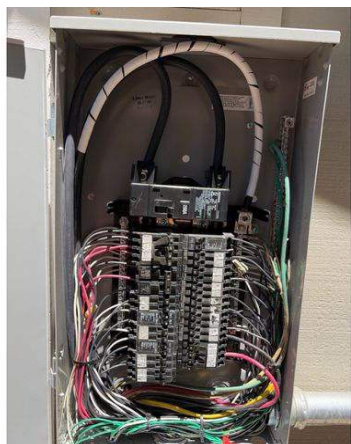
##### Missing Strain Relief.

There is no strain relief for some of the wiring routed through the top and bottom of the listed electrical panel. The inspector recommends that strain relief grommets be installed as a preventive measure against any potential damage or abrasion of the wire insulation/sheathing over time. A licensed electrician should perform this task for safety reasons.

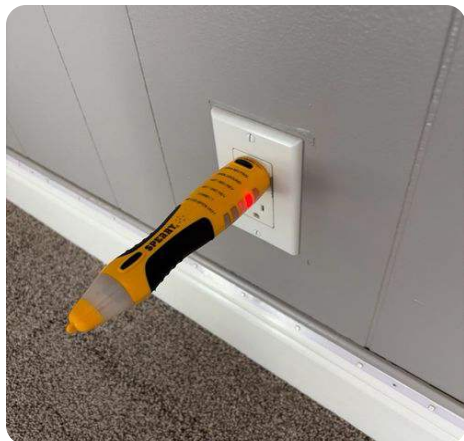
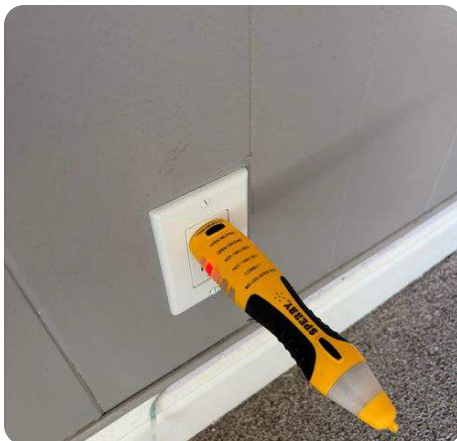
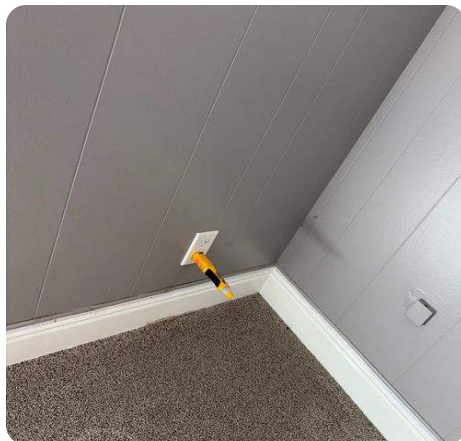
Upstairs south bedroom

One or more outlets were found to have an open ground. Correcting the open grounds in the electrical system is recommended to ensure safety for occupants and proper functioning of the outlets. A qualified electrician should be hired to evaluate and repair this issue.

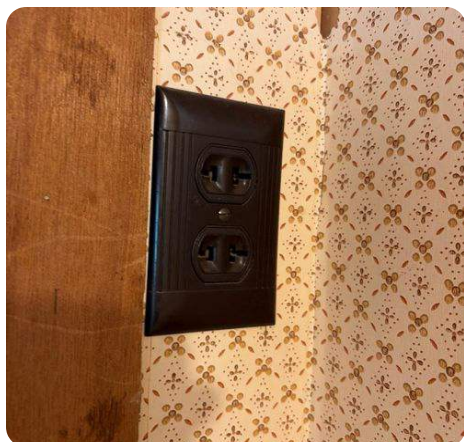
Upstairs bedroom closet

### Two Prong Outlets Present

The presence of one or more two-prong outlets was observed. It is recommended to upgrade these outlets to three-prong outlets to ensure proper grounding and to meet modern electrical safety standards. This upgrade should be performed by a licensed electrician to ensure compliance with local building codes.

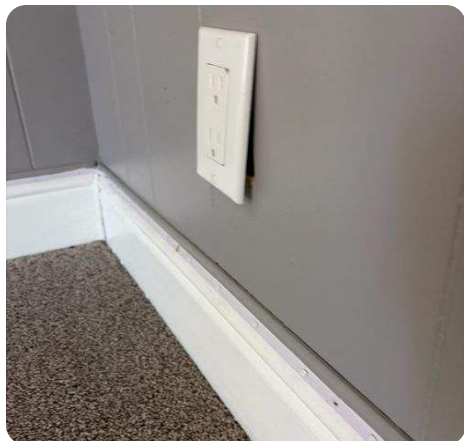
Upstairs south bedroom

### Loose Outlet

There is a loose outlet in the home which could lead to connectivity issues and pose a safety hazard. It is recommended to evaluate and repair the outlet as soon as possible. A qualified electrician should be contacted to properly address and fix the loose outlet to ensure safety and functionality.

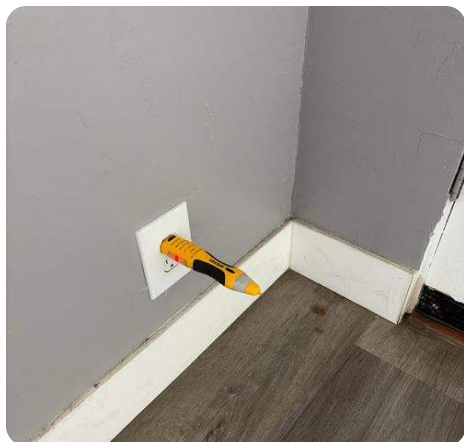
Near front door

### Reversed Hot Neutral Wiring

The interior GFCI outlet has reverse hot neutral wiring, which can pose a safety hazard. This issue should be evaluated and repaired by a qualified electrician to ensure proper wiring and prevent potential electrical shocks or damage to appliances connected to the outlet.

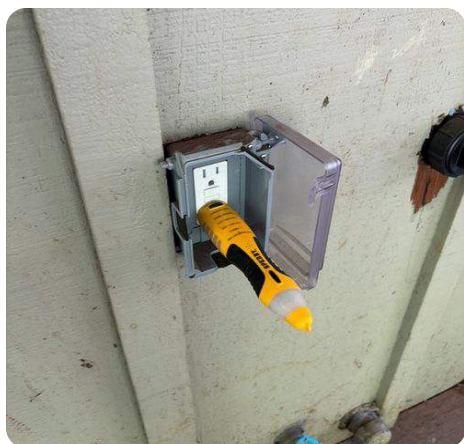
Front of home

### Dead Outlet

One outlet in the home does not have electrical power. The inspector found no tripped breakers or tripped GFCI's. We recommend contacting a reputable licensed electrician for further assessment and correction of this issue.

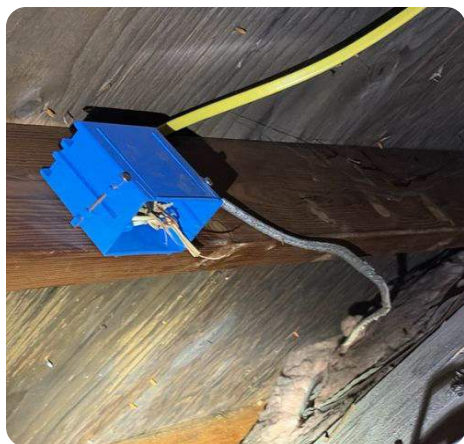
Attic

#### Open Junction Box

An open junction box containing exposed wire connections was observed within the home at the time of the inspection. Junction box covers offer protection to the wire connections, limits debris and rodent access, while containing any potential arcing within the box. It is recommended that an approved cover be installed by a qualified professional.

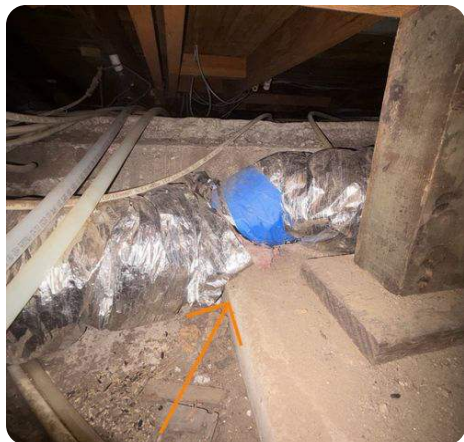
The HVAC ducting within the crawlspace was found to be in direct contact with the soil. Soil contact leads to ducting deterioration over time and it is recommended that the installation be further evaluated and either repaired or replaced by a heating and air conditioning professional.

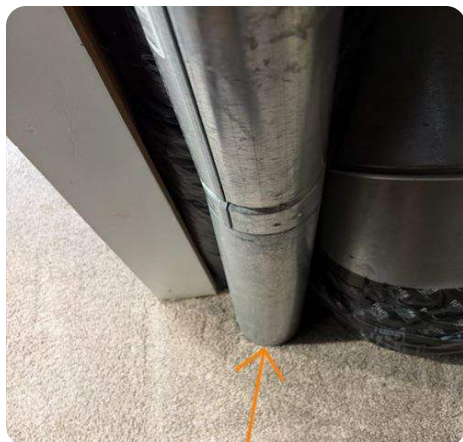
### Furnace Flu In Contact With Carpet

The furnace flue was observed in contact with carpet. Flue venting components should be installed with the required clearance from combustible materials in accordance with the manufacturer's installation instructions and applicable building standards. Improper clearance may present a potential fire hazard. Contact to qualified HVAC technician for further evaluation or repair.

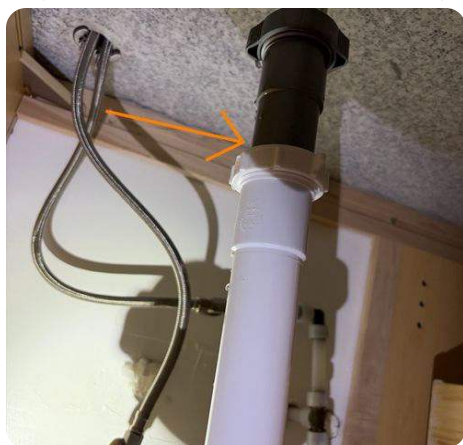
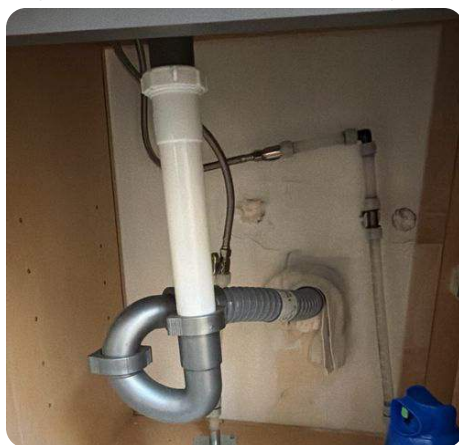
Downstairs bathroom

#### Waste Line Drain Leak

A leak was observed in the drain/waste, line. Evaluating the plumbing system's integrity and addressing any leaks is crucial to avoid additional damage and potential water-related issues. Contact a qualified plumber for further evaluation and repairs.

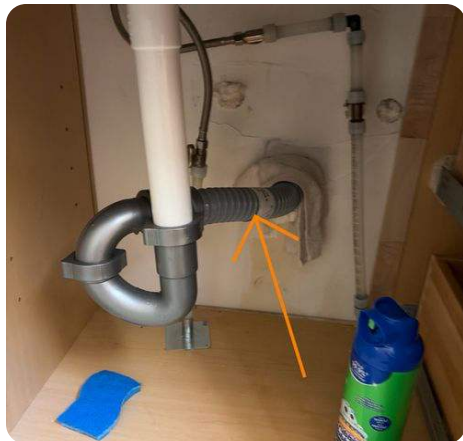
Downstairs bathroom

#### Flex Piping

Flex piping was observed in the drain, waste, and vent system. While flexible and easy to install, it is important to be aware that flex piping may be more susceptible to leaks and may not be appropriate for all uses. It is recommended to assess the condition of the flex piping and consider necessary repairs or upgrades. Contact a qualified plumber to evaluate the suitability of the flex piping and determine if any repairs or replacements are needed.

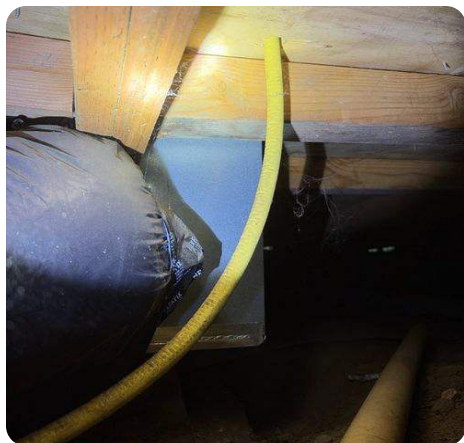
Corrugated Stainless Steel Tubing (CSST) is present on the gas supply system. It is important to ensure that the CSST is properly bonded and grounded to reduce the risk of damage from lightning strikes or electrical faults. It is recommended to verify the installation meets current safety standards and codes. A licensed plumber or qualified professional should inspect the system for proper bonding and grounding.

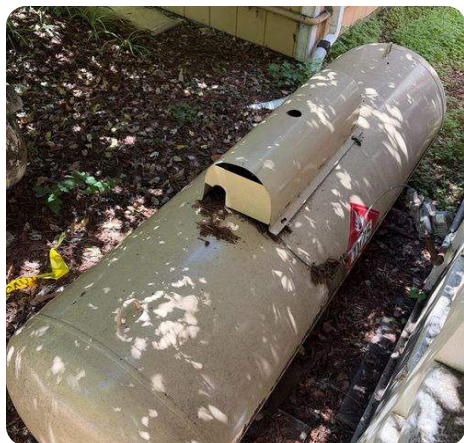
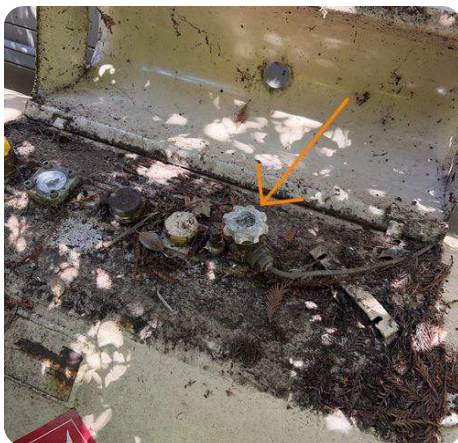
The gas plumbing system was evaluated during the home inspection and was found to be in functional working condition. No issues were identified with the gas plumbing system. Regular maintenance and inspection are recommended to ensure continued optimal performance.

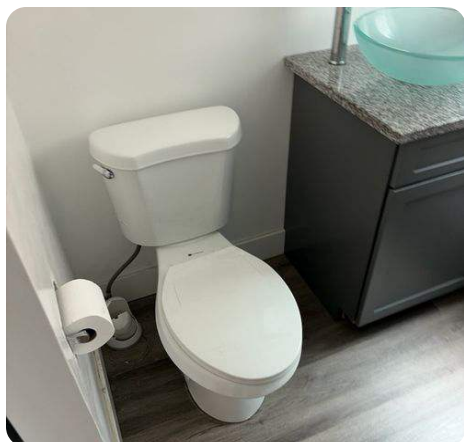
Downstairs bathroom

One or more toilets were found to be loose, as evident by movement or rocking when pressure is applied. A loose toilet may cause leaking or damage to the wax seal, potentially resulting in water damage to the subfloor or ceiling below. It is recommended to assess and repair the toilet promptly to avoid future issues. Contact a qualified plumber to correctly secure the toilet.

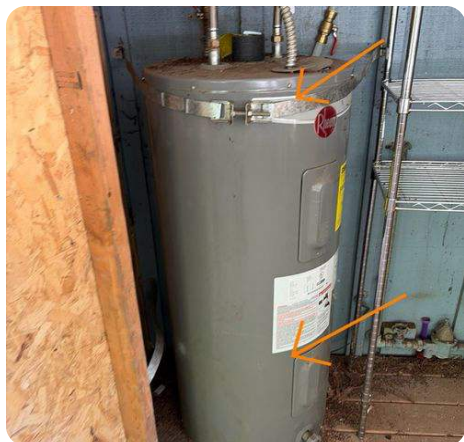
The water heater is equipped with one seismic strap. This current standards are that there be two tie down straps around the top and bottom 1/3s of the tank to prevent it from moving in the event of an earthquake. In addition, the fasteners securing the present strap are undersized and do not meet current standards. Contact a qualified handyman for installation of an appropriate size strapping system.

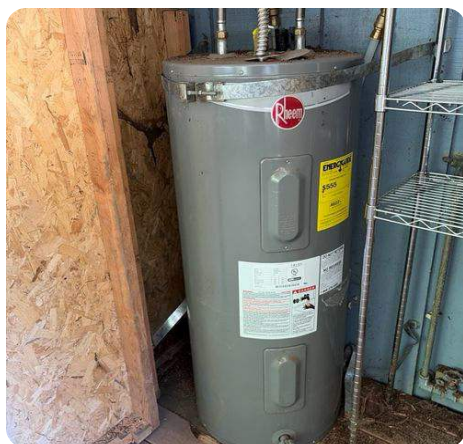
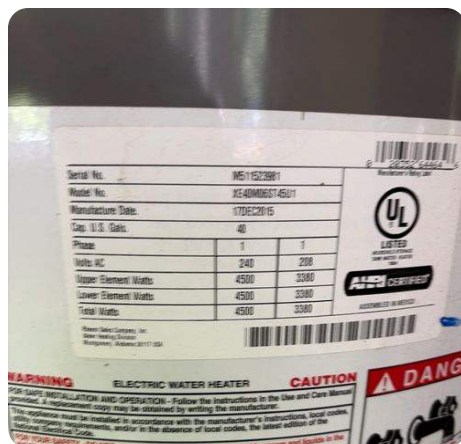
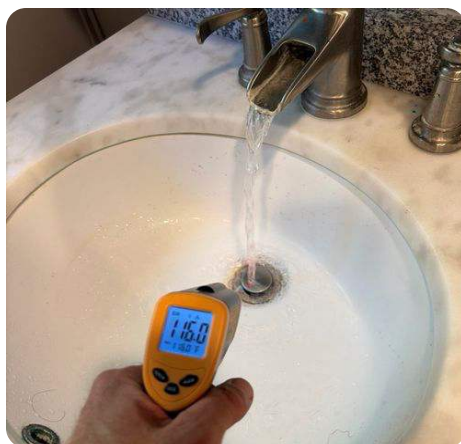
The water heater is about 11 years old. The life expectancy of a water heater is typically 8-12 years from the installation date, although there are exceptions on both sides. As a preventative maintenance recommendation, the water heater should be drained periodically to remove sediment buildup in the tank. The recommended setting for a residential water heater is under 120 degrees Fahrenheit to prevent scalding.

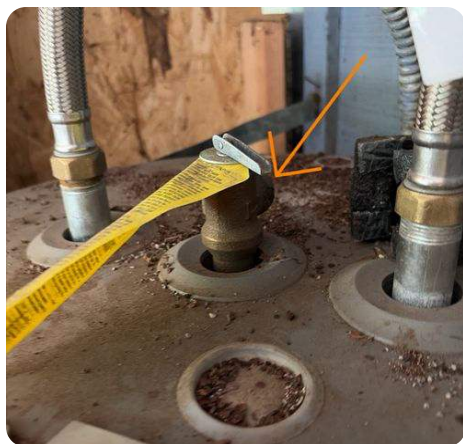
There is no discharge pipe attached to the water heater's temperature pressure relief valve. This pipe is essential to prevent someone from being sprayed with hot water if the valve is activated. While activation of the temperature/pressure relief valve is uncommon, it typically indicates that the water heater requires servicing or adjustments. For safety, it is recommended to install an approved discharge pipe that terminates 6-24 inches from the floor or to the exterior.

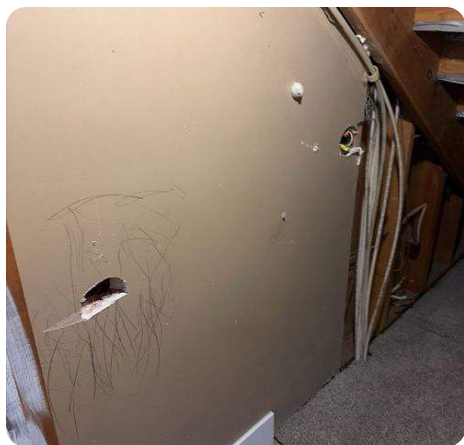
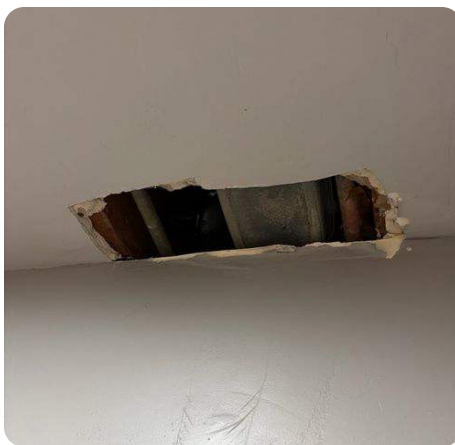
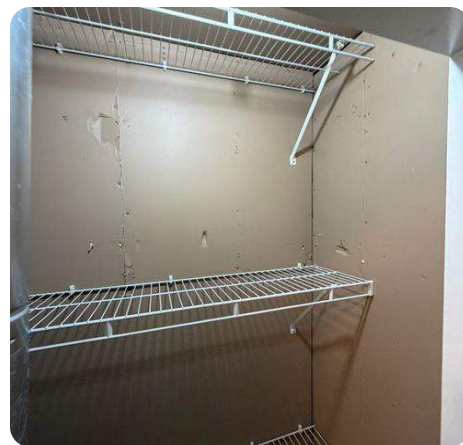
There are various wall areas where there are scratches, nicks, small holes from attaching curtains, or picture hangers, physical damage, stains, or general wear. The conditions are cosmetic in nature and consideration should be given to patching and painting for aesthetic purposes.

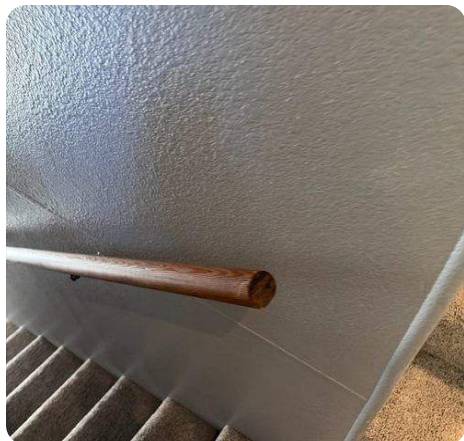
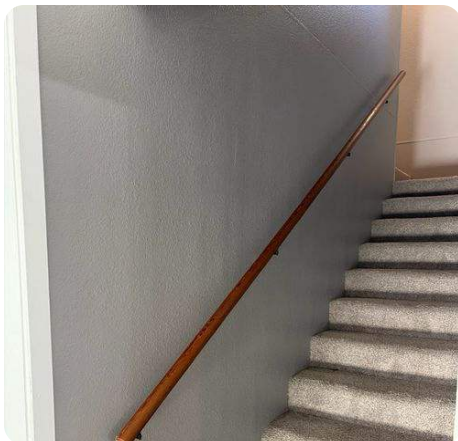
The handrail at the interior stairway is missing returns to the wall at the ends of the rail. A return is meant to help prevent falls and injury. We recommend contacting a qualified contractor for repairs.

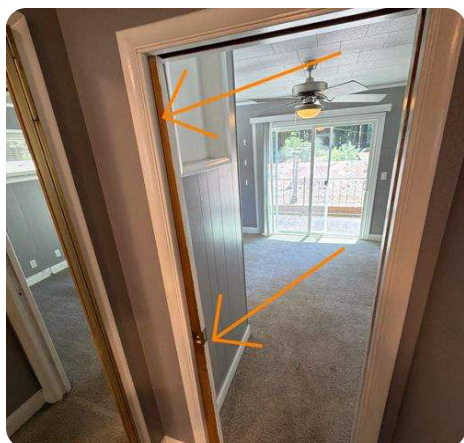
The pocket door is off track. This issue can lead to difficulty in opening or closing the door properly. It is recommended to evaluate and repair the pocket door track to ensure smooth functionality. A qualified carpenter or handyman can assist in realigning the door on track.

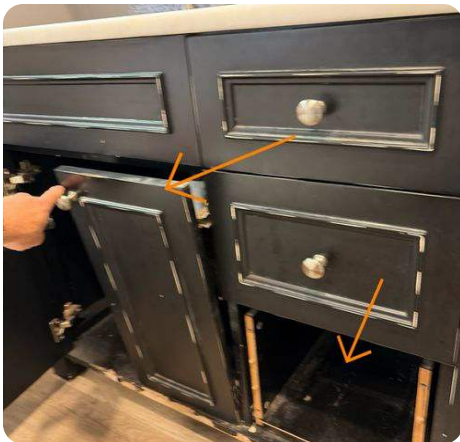
Upstairs bathroom

The cabinet has damage that can affect its appearance and functionality. It is recommended to have the damaged area evaluated and repaired by a qualified cabinet repair professional to restore it to its original condition.

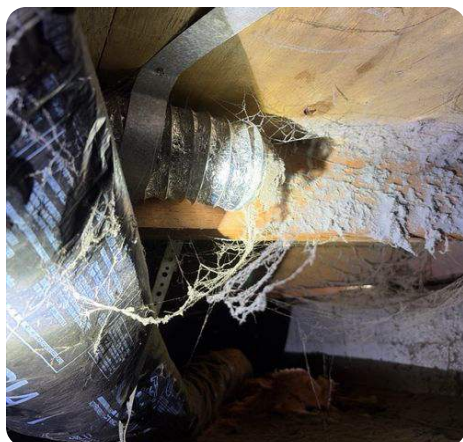
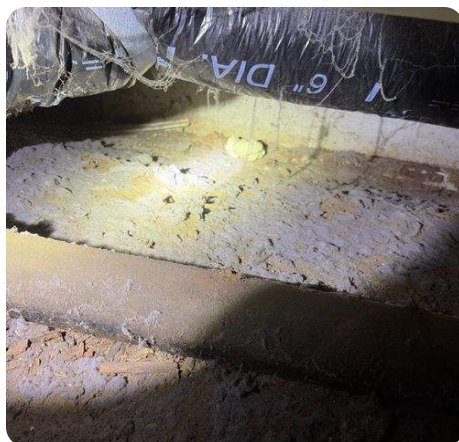
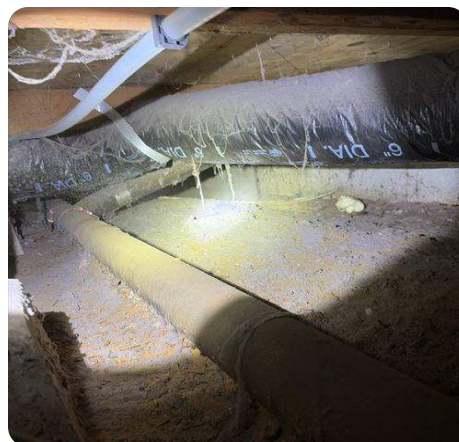
The dryer vent is disconnected. This issue can lead to moisture build-up and potential mold growth. It is recommended to evaluate and repair the dryer vent by reattaching it securely to ensure proper ventilation. A qualified HVAC technician can assist in reconnecting the dryer vent to prevent any further issues.

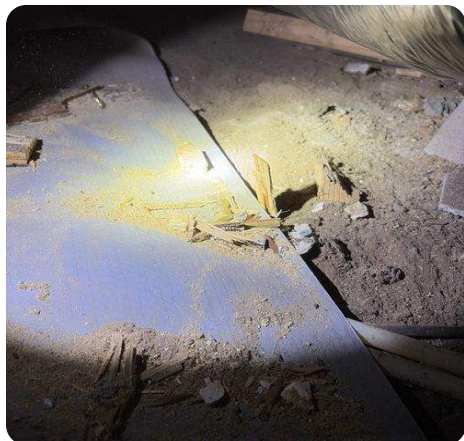
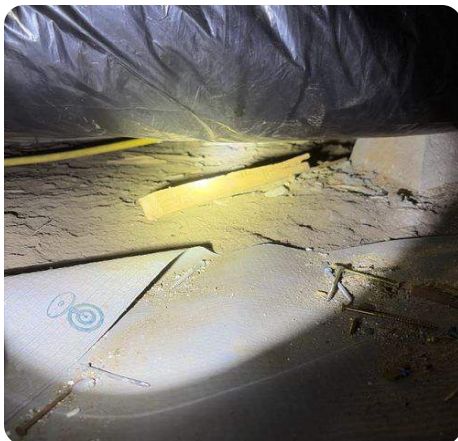
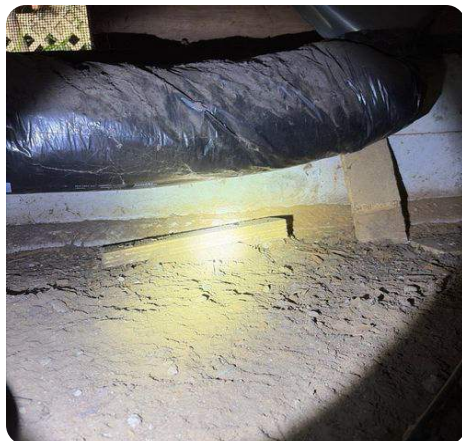
Scrap wood and other debris was noted in the crawl space. Recommend removal of all scrap wood and debris from the crawl space as wood debris/cellulose can lead to insect infestation.
